Vale of White Horse Pool Works

Abingdon

Case Study

Repair and refurbishment works to leisure centre swimming pool

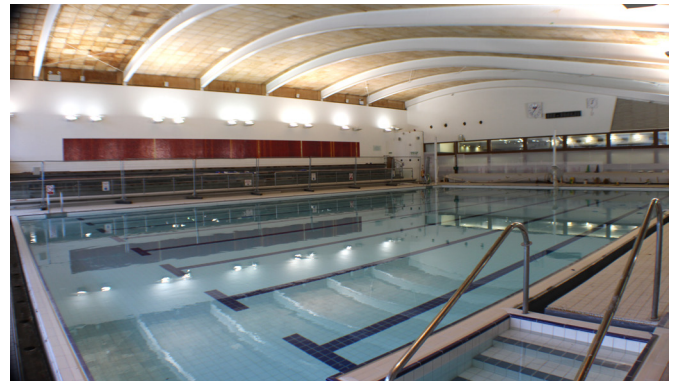
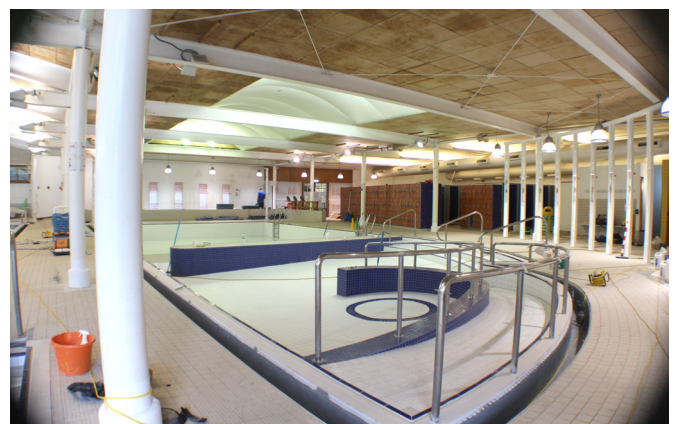
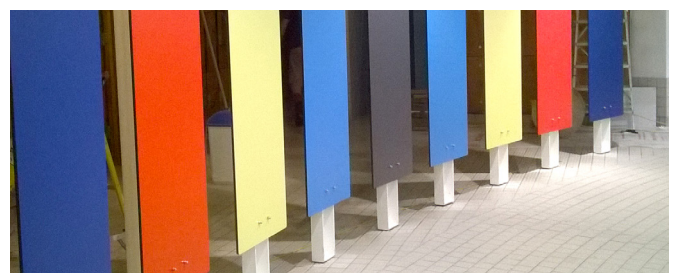
Having been built over 14 years ago, the pool had developed a number of leaks around the edge of the pool which were in need of repair. Francis Construction were contracted to carry out the repairs and refurbishment. Works comprised the removal and replacement of the edge tiles around the pool and a full re-tiling of the main and learner pool tanks.

Extensive concrete repair works were required to the pool and balancing tanks with restricted access to the undercroft. There were a number of steel columns that had severe rust which had to be prepared and repairs carried out with carb on wraps following shot blasting. In addition, we refurbished the shower areas and toilet facilities with a visually aesthetic solution.

Whilst these works were taking place, we also brought the changing facilities for the disabled up to date and modernised the shower areas. These works included an adjustable changing table, hoist, a Doc M WC and shower suite.
